TSUNAMI WAVES IN PORT VALDEZ

#### TSUNAMI WAVE DAMAGE AT VALDEZ

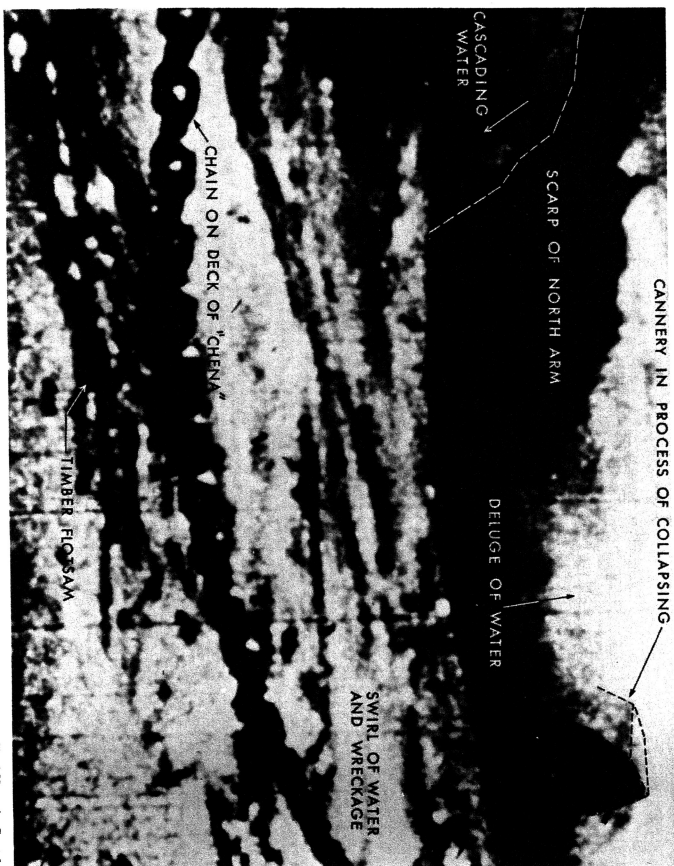
flat slope of the sediments at the east end of Port Valdez. It could not have been a complete and sudden failure because the *Chena* returned on the crest of the first wave (Figures 85c and 86c) and was deposited on the wreckage of the docks. Further, although the docks had disappeared by this time, the portion of the North Arm at the approach to the docks, along with the canneries, was still intact, as proved by Figure 87. This is enlarged from a single frame (No. 110) of the 8-mm motion-picture film, photographed by Fred Numair, crew member of the *Chena*, from the approximate location of Figure 85 (c and d) or Figure 86 (c and d). Figure 87, which shows the canneries engulfed by the passing wave, should be compared with Figure 82, Numair's film (frame 184, Figure 88) shows the disintegration

FIGURE 88 Another view (from the *Chena*) (enlarged from frame 184) of the first tsunami wave destroying the cannery on the North Arm of Valdez Harbor (for location see Figure 85).

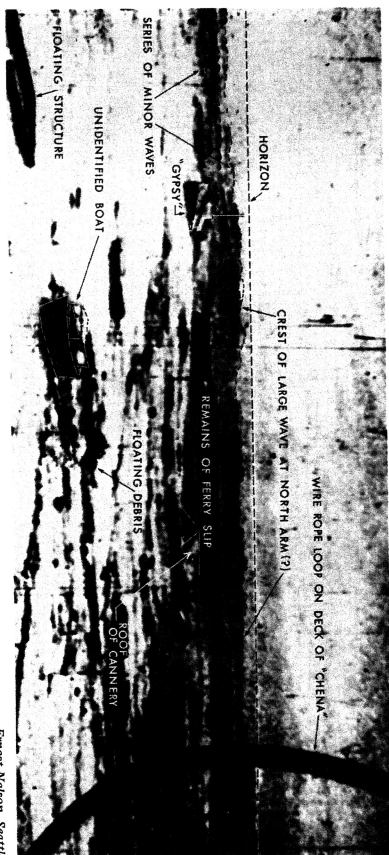
89 (see also Figure 85), which shows the wreckage in the boat harbor. (The authors found that Nelson's film, which had been borrowed soon after the earthquake by one or more organizations, had been cut in many places and resplined in incorrect time sequence. Nelson, in a personal interview in 1966, was greatly upset over this treatment of his film.) The dark spur is believed to be the remains of the ferry slip and the parallel "wave" beyond to be the remnant of the North Arm. The *Gypsy*, the largest yacht in the boat harbor, is just visible off the ferry slip. In the course of the whirlpool-like movements of water between the north and south arms of the harbor, the *Chena* had apparently caromed off the sides of the *Chena* while the latter was still stuck in the mud. In Figure 89 the North Arm cannery roof is believed to be floating alongside the

ferry slip. Subsequently, it was found entrenched in mud flats north of the harbor (see Figure 85).

FIGURE 89 Momentary quiet in the ruins of the boat harbor at Valdez (panoramic composite view from the *Chena*). Yacht *Gypsy* is in left center field. Boat in foreground is unidentified. Cannery roof is believed to be floating in center field (for location see Figure 85).

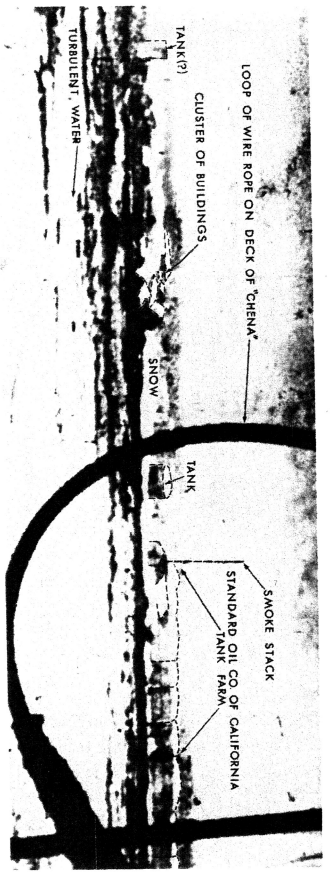
FIGURE 91 Panoramic composite from the *Chena*, south of the harbor of Valdez, showing water draining from the coast under the effects of the submarine slide (for location see Figure 85).

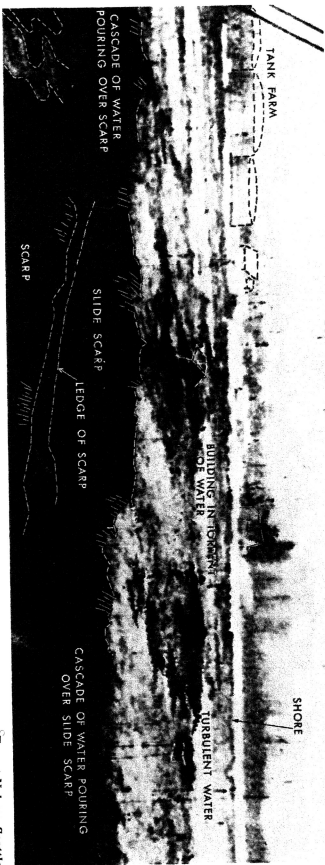
Moments later, Nelson, looking back toward Valdez, photographed this fantastic withdrawal of water and recorded the scene reproduced from several frames of his film as a panoramic composite view (Figure 91), with the direction and location of the picture as in Figure 85. Mud flats were forming behind the ship as it hurried south. The awesome nature of the chasm formed by the submarine slide (see Figure 86f) is shown in Figure 92, photographed

FIGURE 92 Panoramic composite view (from the *Chena*) of the chasm formed by the submarine slide south of the harbor at Valdez (from three frames about 70 frames apart). Water is cascading from the land (for location see Figure 85).

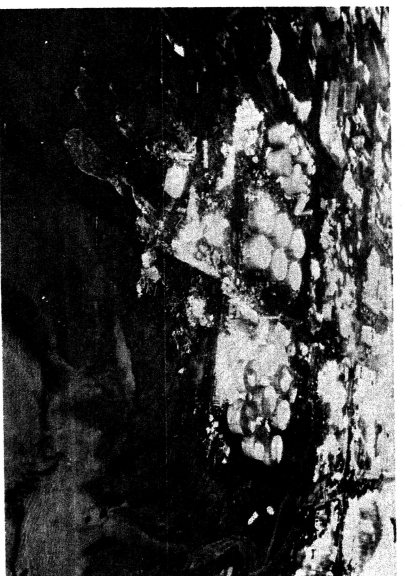
FIGURE 93 Aerial view of the devastation of the waterfront at Valdez in the vicinity of the Standard Oil Company tank farm. Note the relatively undamaged building in left center field (it can be identified in Figure 91). Remains of the south pier are at lower left.

from the approximate position (U) in Figure 85. It is believed that the location of the scarp formed by the slump is revealed in the lower right-hand portion of the aerial photograph (Figure 93) taken within a few days of the earthquake.

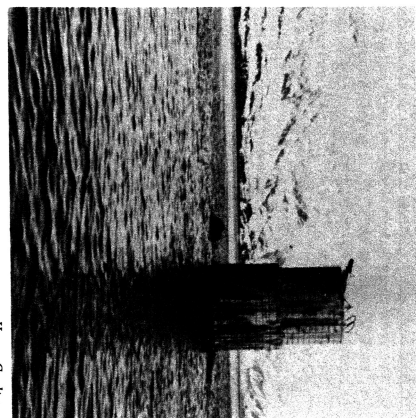
These two slide-generated waves caused considerable runup on both the west and south sides of Port Valdez, as is evident in Figure 96. It is believed that the large wave that hit Valdez about 10 minutes after the earthquake (Figure 84) was one of these waves. Further parts of the waves propagated throughout the Valdez Narrows, destroying the navigation light on top of the lighthouse 35 ft above low water (Figures 96 and 97).

FIGURE 97 Concrete pylon of the navigation light located at the entrance to Port Valdez (for location see Figures 79 and 96). The light was destroyed by a huge wave that passed southward out of Valdez Narrows. Steel reinforcing rods at an elevation of about 37 ft above MLLW were bent in the direction of flow.

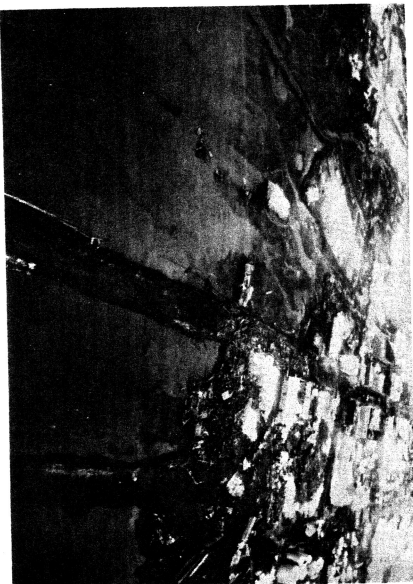
The slides caused the disappearance of the two docks with their warehouses and canneries of the breakwater protecting the small-boat harbor (compare Figures 99 and 100).

FIGURE 100 Aerial view of the Valdez waterfront after the earthquake and tsunami. Compare with Figures 82 and 98.

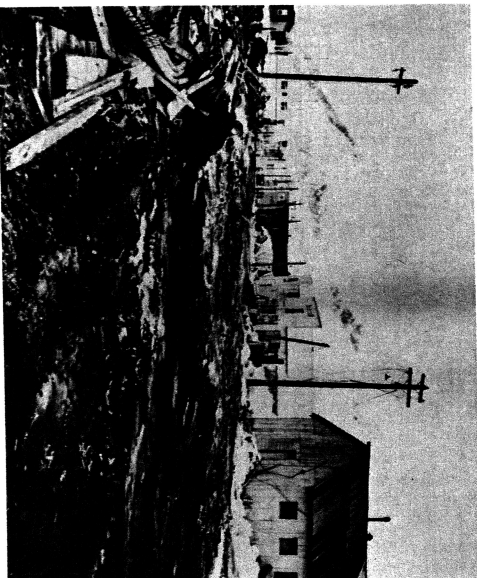
This wave also destroyed three of four buildings at the head of the small-boat harbor and another building along Alaska Avenue (see Figures 85 and 101). The buildings, like most of those in Valdez, were light wood-frame buildings. Particulars of a few buildings damaged or de-

FIGURE 101 View east along Alaska Avenue.

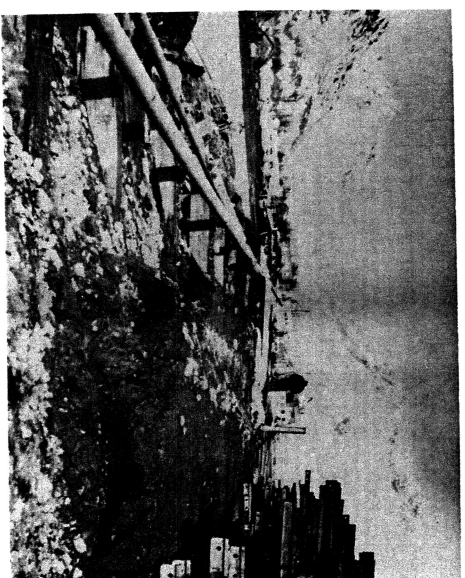
FIGURE 102 Eroded approach ramp to the North dock.

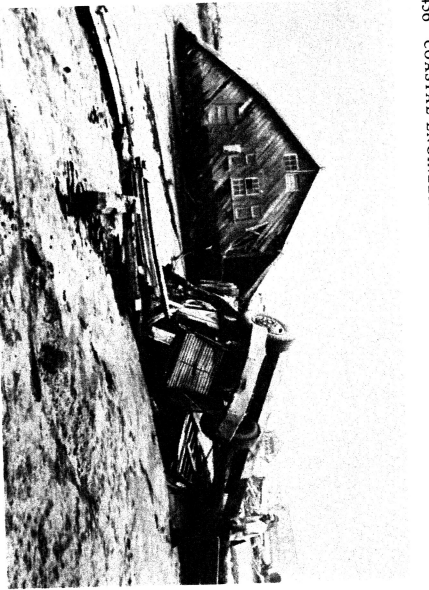
FIGURE 103 Cannery roof and upturned truck on mud flats north of harbor.

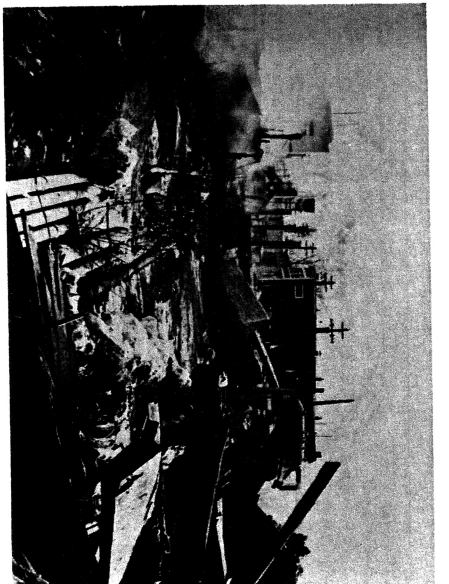
FIGURE 105 View east on Alaska Avenue before cleanup.

The high waves that came in at about 23:45 and 01:35 during the night apparently had no smashing effects. However, they refloated boats and debris, some of the wooden structures were also floated free but were apparently not moved very much. These two waves were responsible for most of the wetting damage to buildings, homes, merchandise, and supplies in the commercial establishments along McKinley Street and west of it. The water was heavily silt-laden, and large volumes of silt were deposited in and around buildings. The backwash of the last wave had a strong current, and debris and beached boats were washed out into the bay. Some of the general muddle on the waterfront is well illustrated in Figures 105 and 106.

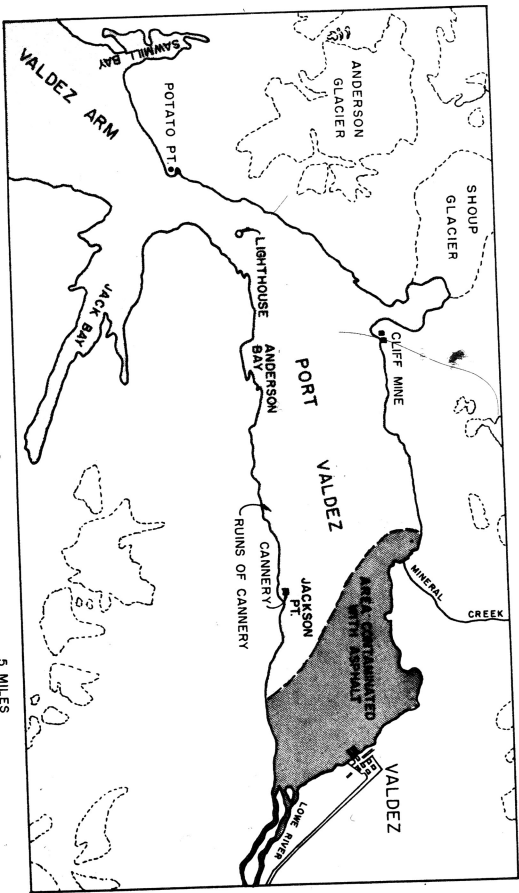
One of the asphalt storage tanks at the Standard Oil Company tank farm was punctured during the earthquake, probably by floating debris. The escaping asphalt (Figure 104) contaminated a large area of Port Valdez. There was also gasoline leakage from the tanks, and at

FIGURE 104 Map of Port Valdez, showing the area contaminated by asphalt from damaged oil tank farm. (From F. Maehamara, 1964).

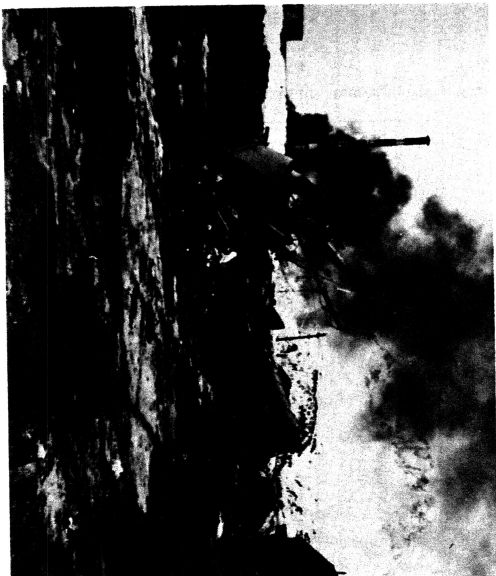
FIGURE 106 View south on Water Street.
