Sediment scour and deposition within harbors in California (USA), caused by the March 11, 2011 Tohoku-oki tsunami

Rick Wilson ^{a,*}, Clif Davenport ^b, Bruce Jaffe ^c

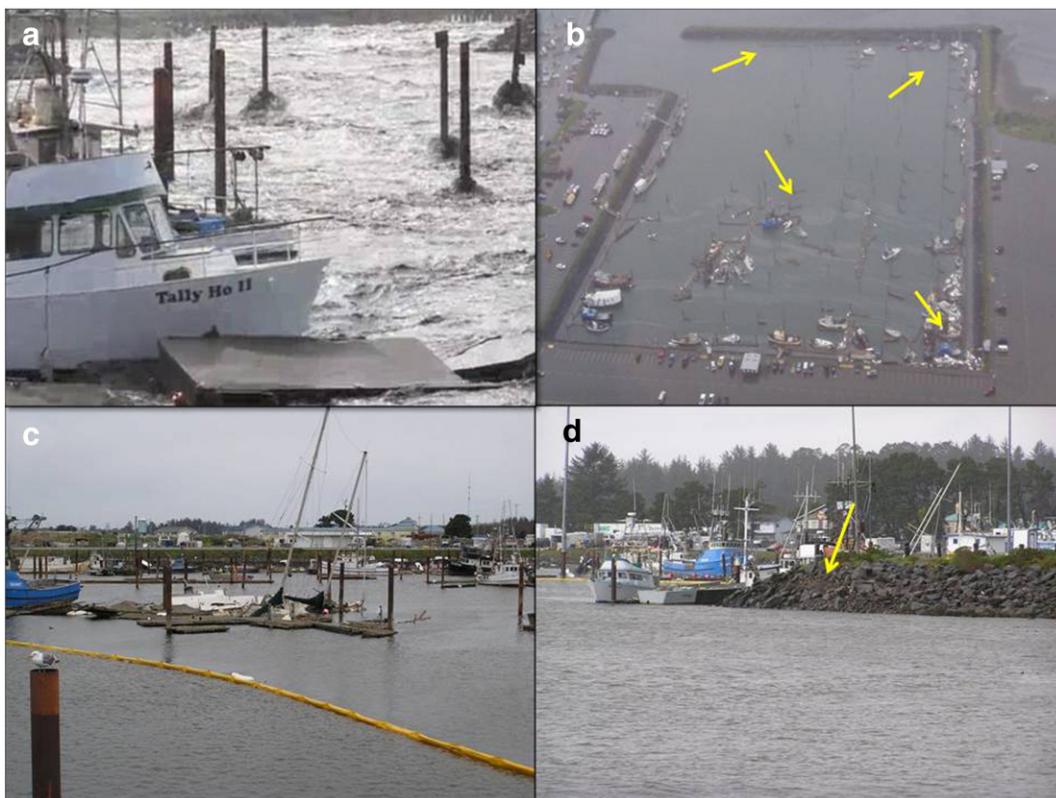
Fig. 2. Tsunami currents and damage in Crescent City Harbor. (a) Strong currents at the mouth of the Small-Boat Basin and across the center of basin; (b) heavily damaged or destroyed docks. Yellow arrows show areas of sediment accumulation; (c) sunken boat sits on shallow floor of Small-Boat Basin where sediment has accumulated; (d) failure of slopes caused by tsunami scour and undercutting.

Fig. 2b and **c** shows harbor debris and shallow areas where sediment accumulated, which appear to coincide with locations where eddies or low current velocity regions were visible on videos. A Federal Disaster was declared for the harbor that allowed for federal and state funding relief of \$19 M of the \$20 M repair costs, leaving the harbor district to pay \$1 M (in addition to the \$5 M it had to pay to repair damage from the 2006 tsunami, Richard Young, personal communications). According to Coast Guard records, a number of sunken boats leaked fuel and other petroleum products, initiating careful monitoring by state and federal agencies. The fuel was cautiously extricated from the fuel tanks of the sunken boats, which were then removed over a period of several months. Sampling of sediment deposited by the tsunami was required by state and federal agencies to make sure that it was not contaminated and that it was composed of sufficient coarse-grained material to allow for offshore disposal, which is significantly more cost effective than on-land disposal in a landfill. Sampling of the harbor sediment was put on hold for a number of months while regulatory agencies determined the best method to perform sediment analyses. The regulatory review determined that tsunami deposits were of suitable grain-size composition and lacked significant contamination such that they could be placed in USEPA's permitted disposal location (HOODS) offshore of Humboldt Bay, instead of in an onshore landfill, saving millions of dollars in disposal costs. Dredging of the SBB started in September 2011, and as of December 2011, the harbor was still being dredged of tsunami sediments, which totals some 150,000 m³ of material (Weston Solutions, Inc., 2011). In addition, repairs to the protected slopes along the edge of the harbor were required after scour, undercutting and failure occurred (**Fig. 2d**). According to Harbormaster Richard Young, dredging delays significantly reduced harbor revenue needed to produce the harbor's matching funds required to obtain federal and state funds, a problem that will cause additional delays in harbor repair projects.

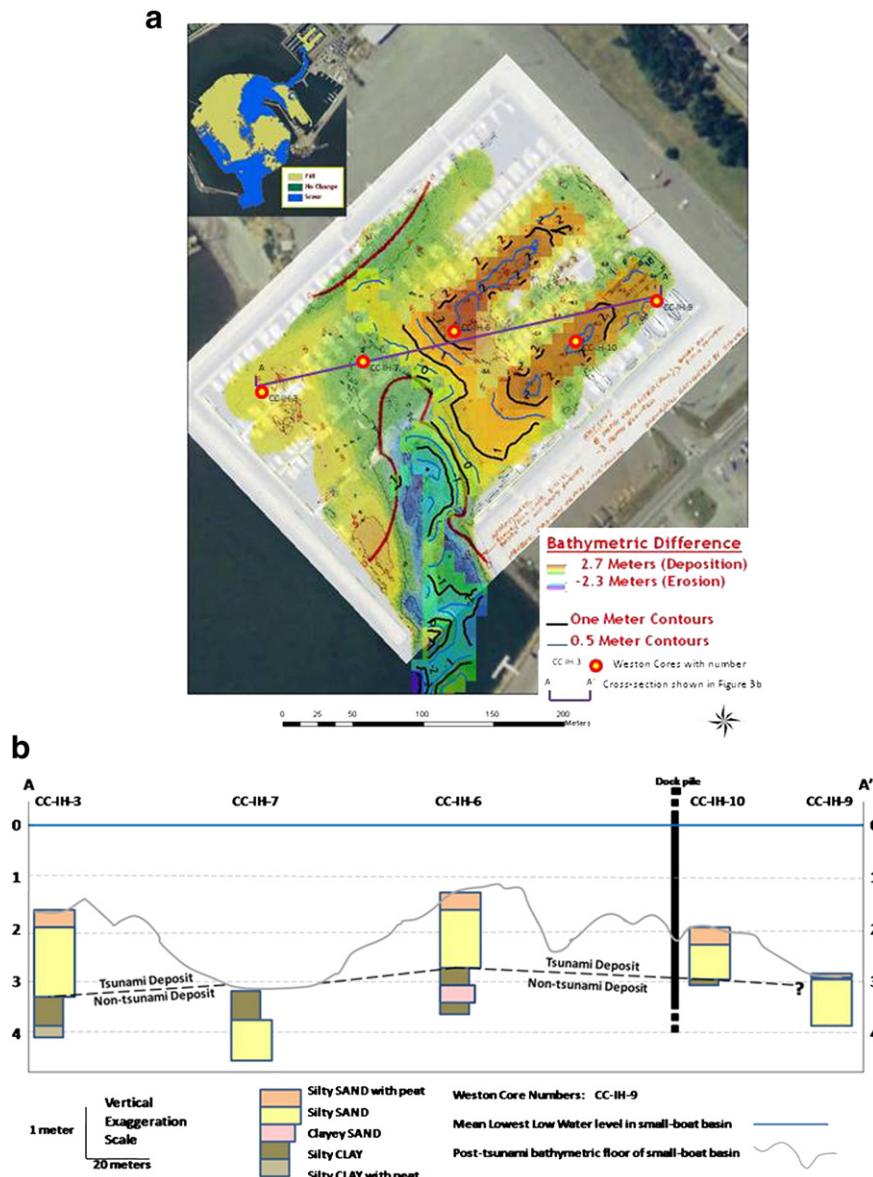
Fig. 3. (a) Areas of scour and fill in the Crescent City Harbor Small-Boat Basin determined by differencing multi-beam bathymetry collected by NOAA on March 16–21, 2011 and November 2008, superimposed on similar, more extensive raster image provided by Harbormaster (Stover Engineering, 2011); (b) cross section showing the post-tsunami bathymetry, sediment composition, and correlations between tsunami and non-tsunami deposits within the Small-Boat Basin.

Two sets of pre- and post-tsunami bathymetric data were obtained for the Crescent City Harbor. Single-beam sonar depth data was collected on 21 February 2010 and 30 March 2011 by the USACE (Moore, 2011) as part of their ongoing assessment of the harbor entrance channel conditions (e.g., "Conditional" survey). Datasets were limited to the main entrance channel and do not extend into the SBB or other parts of the outer harbor. NOAA's multi-beam bathymetry collected on November 18–23, 2008 and March 17–21, 2011 (NOAA, 2008 and NOAA, 2011a) provided additional sets of data with a larger area of coverage for Crescent City Harbor, including the SBB. There were no significant differences between the pre-tsunami bathymetric data from NOAA's 2008 and USACE's 2010 surveys where they overlapped, supporting the use of the larger dataset from 2008 for comparisons with the post-tsunami data. Therefore, comparisons between the NOAA 2008 and post-tsunami 2011 data were utilized in the bathymetric change analyses as shown in **Figs. 3** and **4**.

Figs. 3a and **4** show bathymetric changes observed between the 2011 and 2008 NOAA sounding events within portions of the Crescent City SBB and outer/mid-harbors, respectively. The area of overlap between the two survey events is approximately 0.67 km². Within the overlap area, about 289,360 m³ of sediment was scoured. Deposition amounted to approximately 154,600 m³, and covered approximately 55% of the survey overlap within both the outer and inner harbor areas. However, these numbers are minimums, because the surveys do not extend throughout all parts of the harbor, and they do not include deposition in the western portion of the SBB that was identified on the Stover Engineering figure (included on **Fig. 3a**). Overall, it appears that the tsunami removed sediment from the harbor (65% of total volume change), although deposition was significant and created navigation problems within portions of the mid-harbor and shoaling within the SBB to the point where much of the inner harbor was unusable.

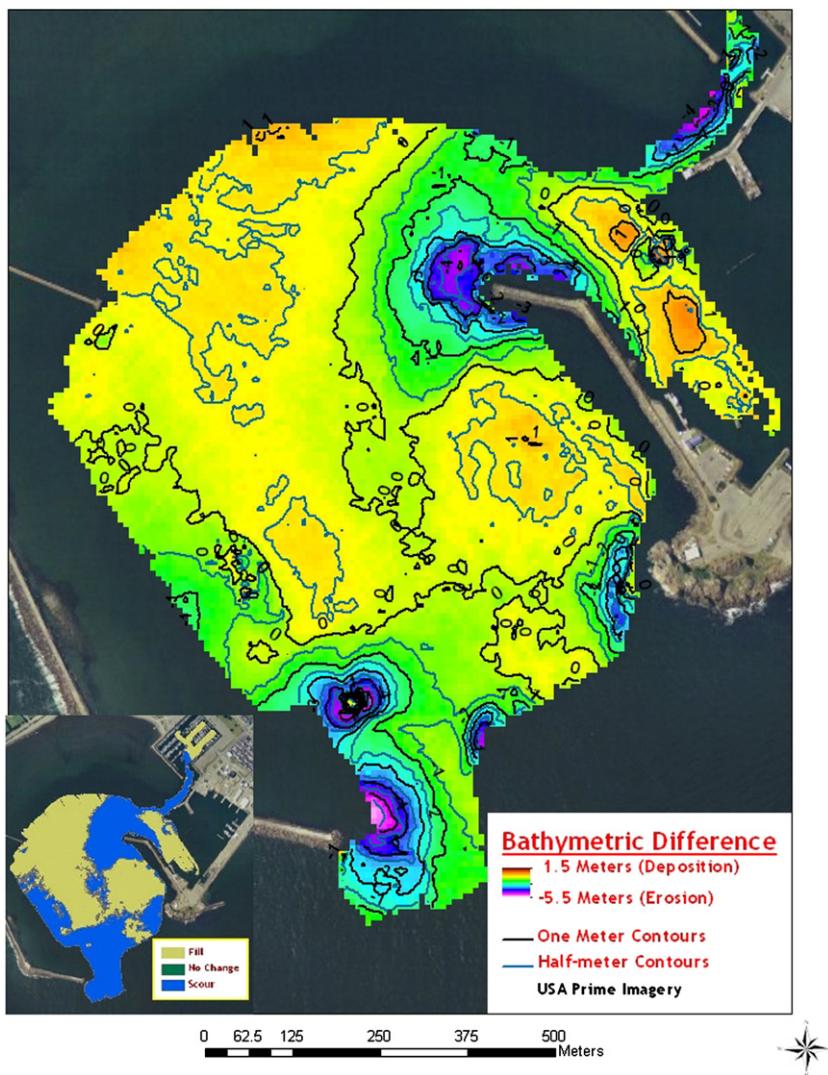
Fig. 4. Areas of scour and fill in the outer and middle portion of the Crescent City Harbor determined by differencing multi-beam bathymetry collected by NOAA on March 16–21, 2011 and November 2008.

Tsunami scour also occurred around the end of the Whaler Island jetty and extended southeastwards into the southeastern mid-harbor along the inboard side of the jetty (Fig. 4). A ridge of sediment up to 1 meter thick was deposited along the central portion of the entrance to the Outer Boat Basin (OBB), parallel to the scoured zone. Conditions resulting in observed scour and deposition relationships hypothesized above for the SBB may be similar for the OBB. The wave

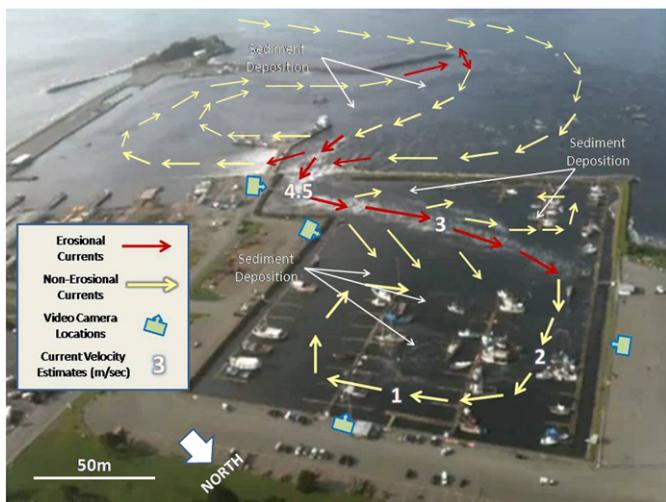
Fig. 5. Tsunami flow-regime map for Crescent City Harbor. Current directions and velocities, and areas of sediment erosion and deposition are based on observations of the various (30) ground-level and aerial video, pre- and post-tsunami bathymetry, and sediment analyses.

material carried from outside the SBB may have increased the density of the water, possibly aiding the suspension and movement of the coarser material. Entrained sediment was deposited on either side of the scour/thin deposit zone, likely as a result of flow deceleration and slower water velocities caused by eddies and back-pressure from reflected waves. The decrease in flow velocity is associated with the tsunami's collision with the SBB boundary and, to a lesser extent, the docks before they were damaged. Thicker deposition throughout a larger portion of the SBB east of the main scour zone implies that much of the entrained sediment was directed this way, preferentially deposited in the channels between docks and around large accumulations of tsunami debris (Fig. 5).

To summarize, major scour occurred at outer and mid-harbor jetties and at the mouth of the SBB due to water current velocities observed to be up to 4.6 m/s (9 kn) (Fig. 5). In the outer harbor, strong

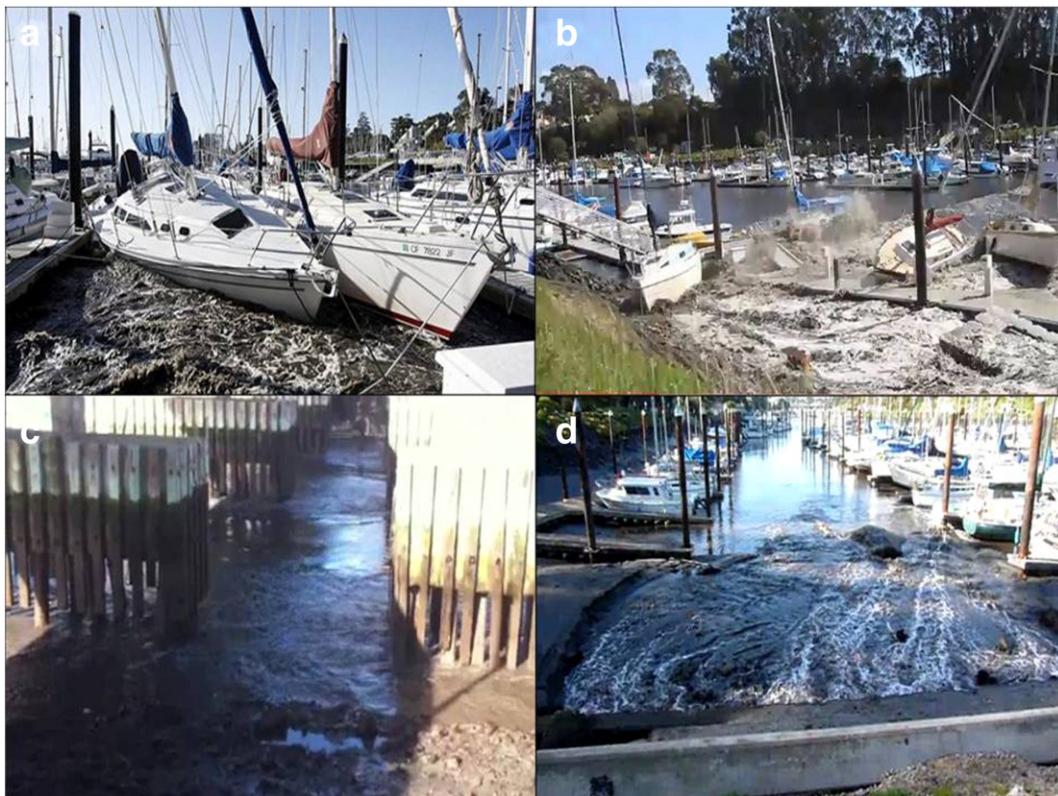
Fig. 6. Tsunami currents, erosion, and damage in Santa Cruz Harbor. (a) Strong currents cause damage to boats within harbor; (b) heavily damaged or destroyed docks as tsunami bores enter the northern part of the harbor; (c) base of bridge foundation exposed and scoured as receding waters rush through the central part of the harbor; (d) scour where drainage from Arana Gulch Creek enters the harbor at the north end.

Though no tide gauge exists within Santa Cruz Harbor, peak tsunami amplitudes of 1.6 to 1.9 m were observed in the harbor (Wilson et al., 2011). In addition to strong currents causing damage to boats and docks (Fig. 6a), approximately 3 h after the first tsunami wave arrival, several large, fast-moving bores were observed traveling to the back (north) of the harbor, causing significant damage to dock infrastructure where the harbor narrows (Fig. 6b). The elongate shape of the harbor likely amplified incoming surges causing the strong currents and bores described (Wilson et al., 2012). The overall damage to the harbor was more than \$28 M, with 14 boats sunk and dozens of others damaged (Mesiti-Miller Engineering, Inc., 2011; Chuck Izenstark, personal communication). Of the harbor's 29 docks, 23 sustained significant damage ranging from severe float cracking to complete destruction. Although sediment scour and deposition was not as significant in Santa Cruz Harbor as it was in Crescent City Harbor, it was still noteworthy in portions of the harbor. As of December 2011, repair work and dredging of tsunami-related sedimentation

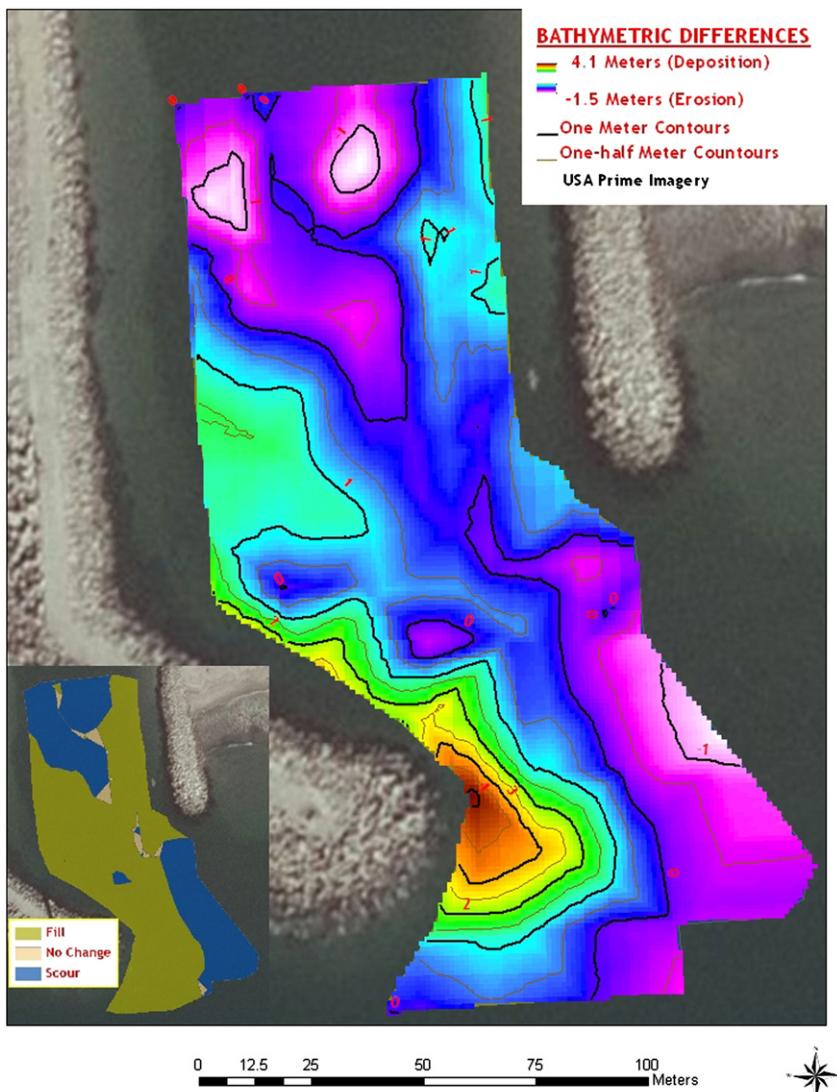
Fig. 7. Areas of scour and fill at Santa Cruz Harbor entrance, determined by differencing Harbormaster soundings collected on March 21, 2011 and February 23, 2011.

[Fig. 7](#) shows bathymetric changes observed between pre- and post-tsunami Harbormaster surveys at the harbor entrance, while [Fig. 8](#) illustrates bathymetric differences between Harbormaster and NOAA surveys conducted in the northern harbor before and after the tsunami respectively. The area of overlap between the two survey events at the harbor entrance is approximately 15,550 m² and approximately 11,950 m² in the north harbor area.

Comparison of the Harbormaster before- and after-tsunami surveys at the harbor entrance indicates that about 5,650 m³ of sediment was scoured, while deposition amounted to approximately 9,900 m³ and covered approximately 64% of the area common to both surveys. However, a different picture emerges when comparing bathymetric surfaces prepared from the Harbormaster pre-tsunami and the March 21, 2011 NOAA post-tsunami surveys. That analysis indicates that approximately 14,800 m³ of sediment was scoured, while only 4150 m³ was deposited over 4.5% of the area common to these two surveys. Causes for the disparity between the two comparisons are not clear at this time, but likely related in part to the differences in how depths were determined and errors introduced when transcribing approximate locations on the harbormaster's hard copies into

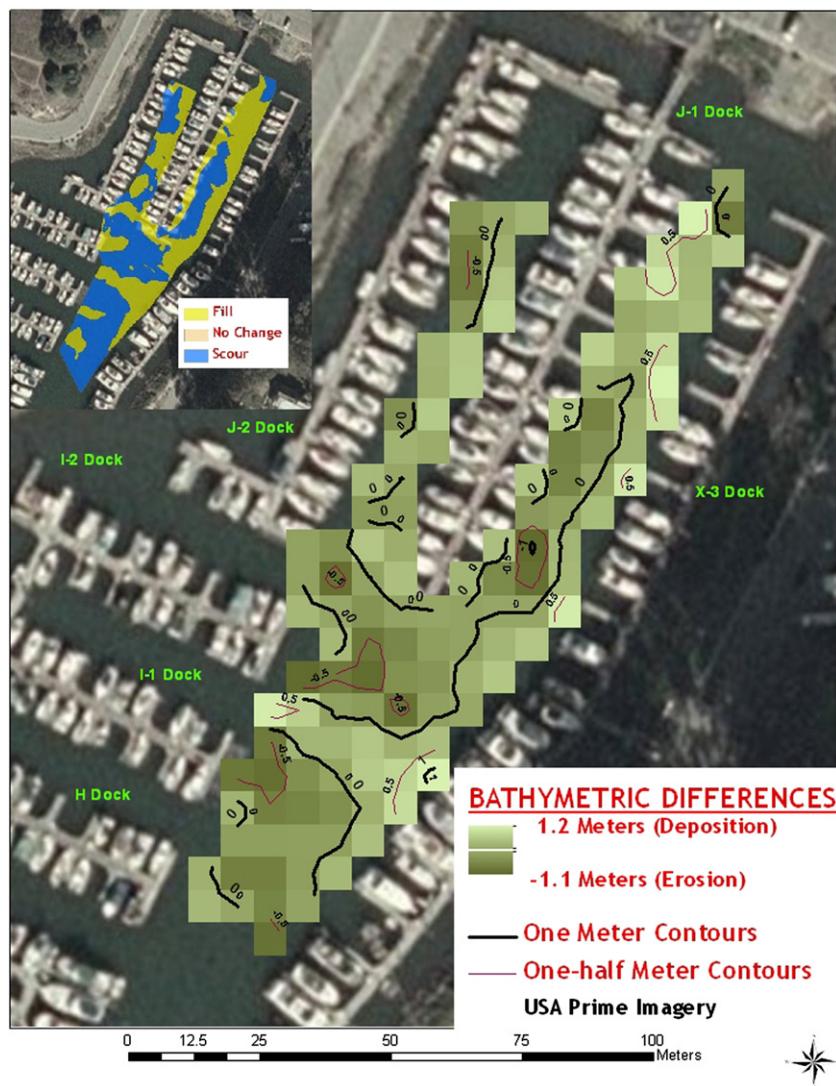
Fig. 8. Areas of scour and fill near the north end of the Santa Cruz Harbor determined by differencing Harbormaster soundings, collected on January 27–28, 2011, and February 21, 2011, with multi-beam bathymetry collected by NOAA on March 21, 2011.

Alternating patterns of scour and sediment deposition occurred at the northern end of the harbor (Fig. 8). In the relatively open areas at the turning basin, alternating areas of erosion and deposition were oriented normal to the tsunami current directions. This pattern of alternating sediment ridge/trough development was interrupted by J1 Dock that bifurcates the end of the harbor. Here, the pattern of scour and deposition is elongated in the ebb/flow direction within the relatively narrow harbor channels on either side of J1 Dock.

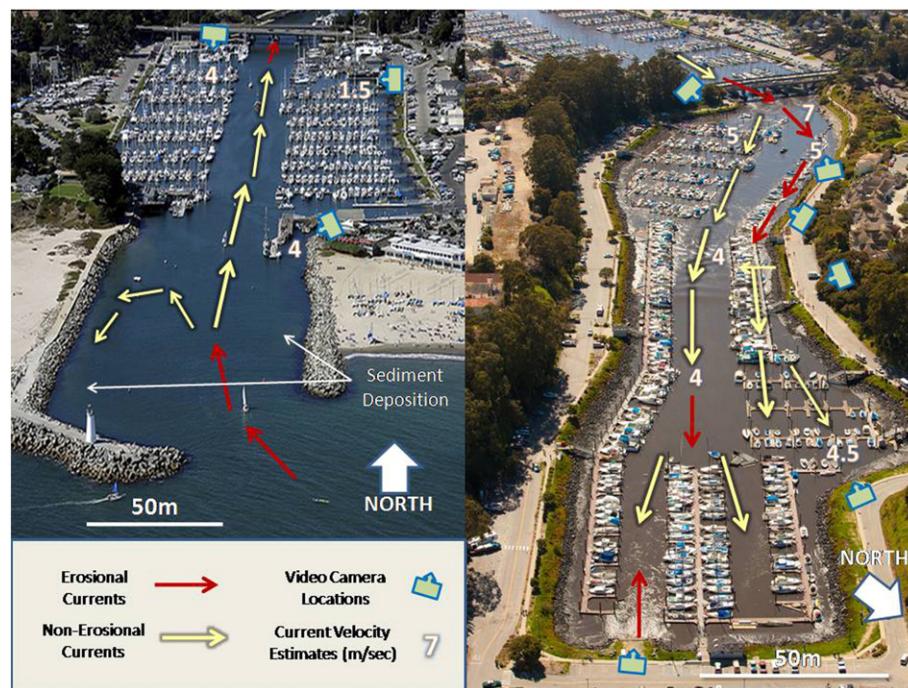
Fig. 9. Tsunami flow-regime map for Santa Cruz Harbor. Current directions and velocities, and areas of sediment erosion and deposition are based on observations of the various (30) ground-level and aerial video, pre- and post-tsunami bathymetry, and sediment analyses.
