TSUNAMI WAVES IN PORT VALDEZ

#### TSUNAMI WAVE DAMAGE AT VALDEZ

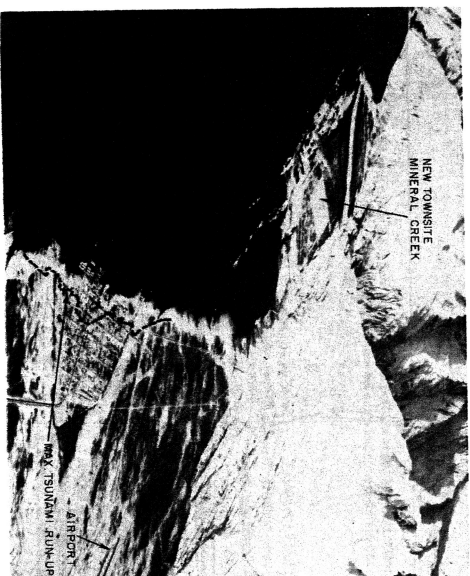
FIGURE 83 Valdez after the earthquake showing approximate extent of inundation from the tsunami.

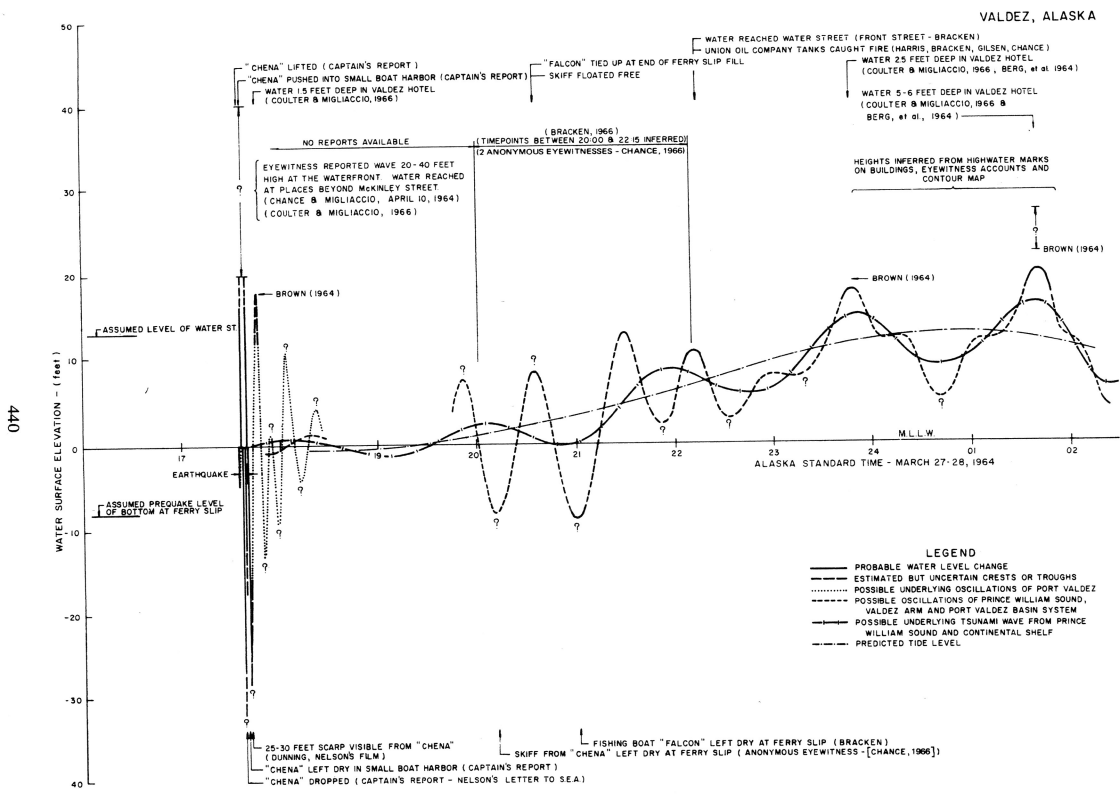
To explain what happened at the waterfront at Valdez, allowing some degree of conjecture to fit the facts, it is possible to infer that water level fluctuated in approximate accord with the manogram presented in Figure 84. We shall try to justify the inference as we proceed.

FIGURE 84 Inferred marigram for Valdez, based on accounts by eyewitnesses and on inductive reasoning.

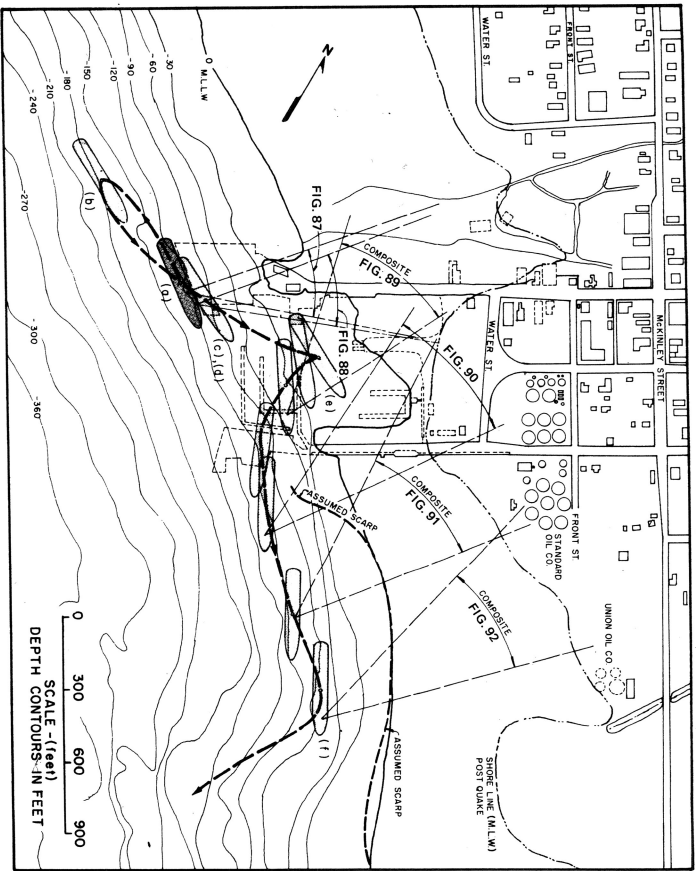
FIGURE 85 Inferred path of the S.S. *Chena* from an initial position at the North Arm Dock, Valdez Harbor, during and after the earthquake. Successive positions of the *Chena* are based on eyewitness accounts and interpretation of color motion pictures photographed from the ship by F. Numair and E. Nelson.

which could mean that the edgewave struck Valdez (midway between the north and south shores of Port Valdez) within 1.1 minute of the start of the earthquake. As an edgewave it would have had the directional effect of sweeping the *Chena* southeast onto the collapsing docks and causing the extraordinary flow of water which carried away the south pier and the cannery from the North Arm.

The returning edgewave, which would have come about 2.2 minutes later, presumably filled the boat harbor, freed the *Chena*, and caused the northward flow, which may have carried small boats and debris in that direction, as observed by Sturgis.

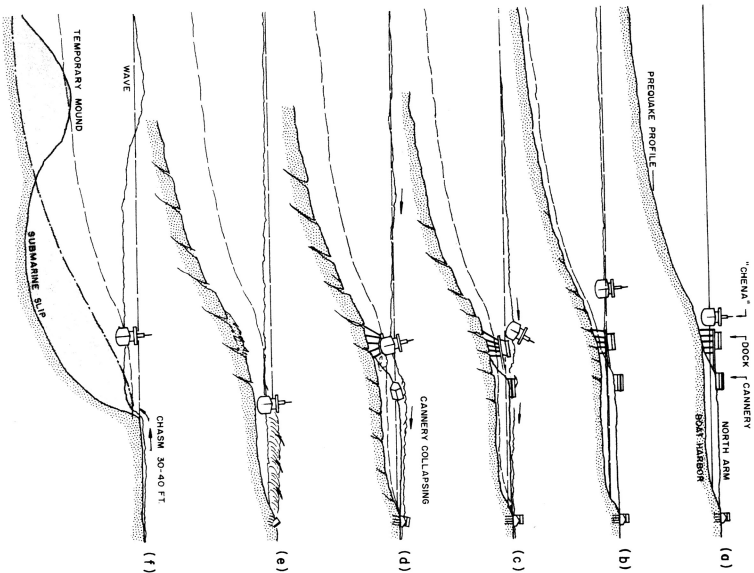
the start of the earthquake the *Chena* went astern in a northwest direction and either shipped or fractured her mooring lines. Sturges, on the third floor of the Valdez Hotel, with a view seaward down Alaska Avenue (Figure 81), was in an exceptionally good position to observe this initial movement (compare Berg and others, 1971; Bryant, 1964b; Chance, 1966, and in press) which was also confirmed by Dunning and Numair. The implied movement of the *Chena* is thus shown in Figures 85b and 86b. This first movement of the *Chena* appears to have been part of a water withdrawal which accompanied the initial subsidence of the docks during the first minute of the earthquake. The earth slump at the harbor (Figure 86b) was at first more in the nature of compaction and partial sliding on the fairly

FIGURE 86 Sequence of schematic diagrams illustrating the inferred movements of the S.S. *Chena* and the destruction of the harbor at Valdez (compare with Figure 85).

flat slope of the sediments at the east end of Port Valdez. It could not have been a complete and sudden failure because the *Chena* returned on the crest of the first wave (Figures 85c and 86c) and was deposited on the wreckage of the docks. Further, although the docks had disappeared by this time, the portion of the North Arm at the approach to the docks, along with the canneries, was still intact, as proved by Figure 87. This is enlarged from a single frame (No. 110) of the 8-mm motion-picture film, photographed by Fred Numair, crew member of the *Chena*, from the approximate location of Figure 85 (c and d) or Figure 86 (c and d). Figure 87, which shows the canneries engulfed by the passing wave, should be compared with Figure 82, Numair's film (frame 184, Figure 88) shows the disintegration

Figure 86f, which envisions the submarine slide, also suggests the formation of a wall of water on the seaward side of the *Chena*. This "wall," reported by Sturges (Byant, 1964b; Chance, 1966, and in press), was observed by Dunming, a longshoreman who survived disaster in the *Chena*'s hold and reached the deck. This slide and the attendant wave effect almost certainly occurred after the earthquake and were probably promoted by the major drawdown of water, shown in Figure 84 to have occurred about 5 to 6 minutes after the start of the earthquake.

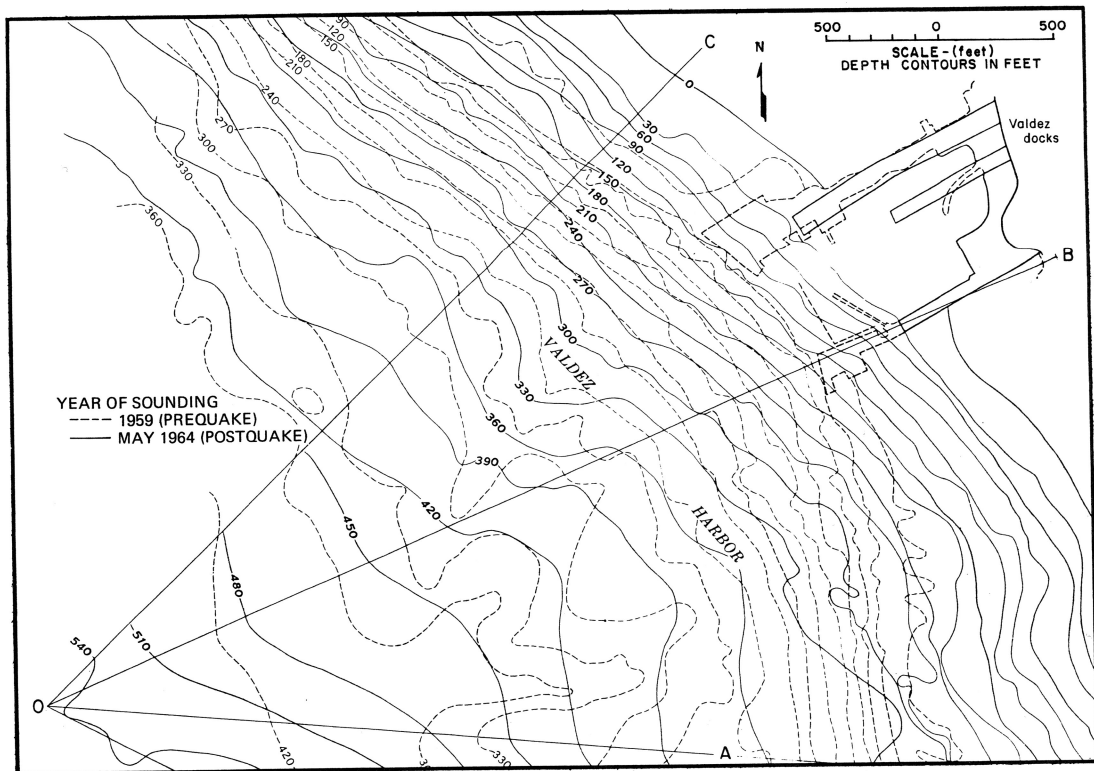
FIGURE 94 Precarthritis and postearthquake soundings at Valdez. (After Coulter and Migliaccio, 1966).

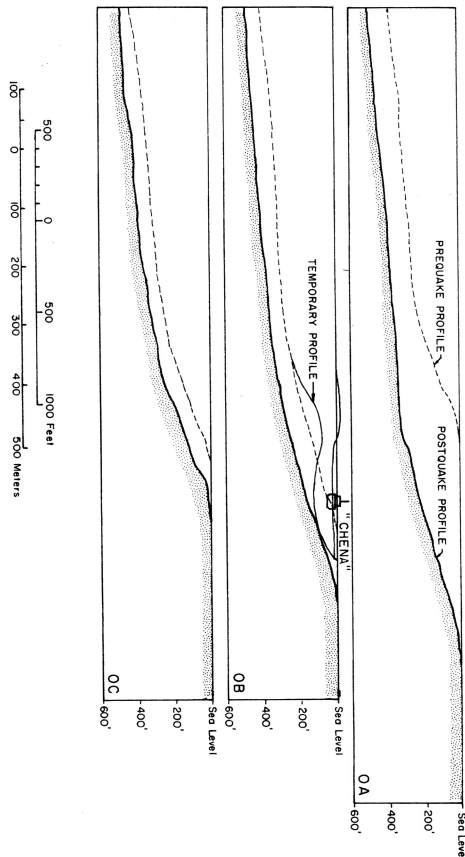
FIGURE 95 Profiles of the sea bed near Valdez before and after the earthquake. Section lines are shown in Figure 94. *Chena's* approximate position when scarp was visible is indicated schematically in profile OB. Dashed lines represent preearthquake profiles, and solid lines denote postearthquake profiles.

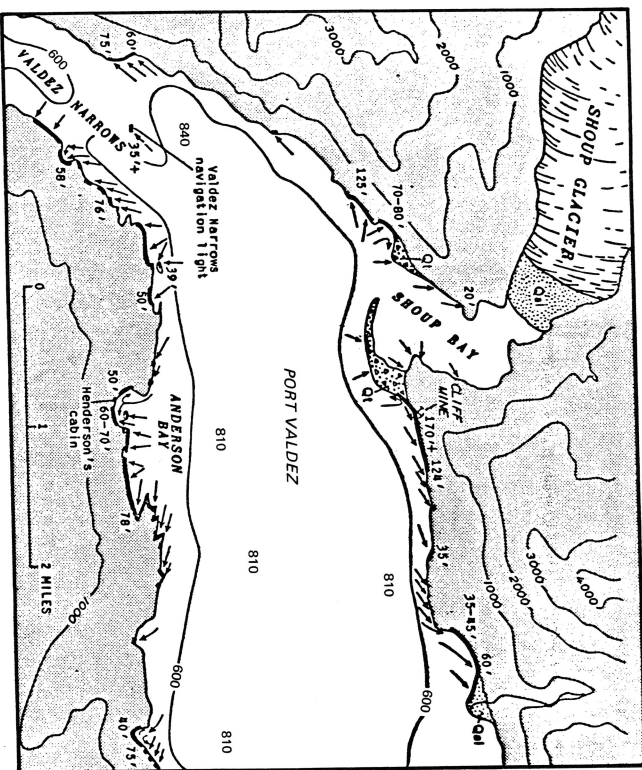
Figure 96 shows that the waves generated at the west end must have been singularly powerful to have produced the tremendous runup recorded at different places (Platker and Mayo, 1965). From this it is assumed that there were two submarine slides at the mouth of Shoup Bay, one near the abandoned Cliff Mine and one on the west side of the entrance of Shoup Bay. Shoup Bay occupies a hanging valley whose floor is more than 500 ft above the bottom of Port Valdez. The Shoup Glacier has left a high deposit of glacial debris that blocks the entrance to Shoup Bay. This material is presumed to have slumped. The first wave obliterated all the stable buildings at the Cliff Mine site, left

FIGURE 96 Heights and inferred directions of local waves in the western part of Port Valdez. Heavy line along shore indicates distribution of damage; numerical is measured maximum runup. Shaded pattern, bedrock; dotted pattern, alluvium and intertidal mud; triangular pattern, terminal moraine of the Shoup Glacier. Contour interval on land is 1,000 ft; submarine contour interval is 600 ft. (From Plafker and Mayo, 1965).

These two slide-generated waves caused considerable runup on both the west and south sides of Port Valdez, as is evident in Figure 96. It is believed that the large wave that hit Valdez about 10 minutes after the earthquake (Figure 84) was one of these waves. Further parts of the waves propagated throughout the Valdez Narrows, destroying the navigation light on top of the lighthouse 35 ft above low water (Figures 96 and 97).

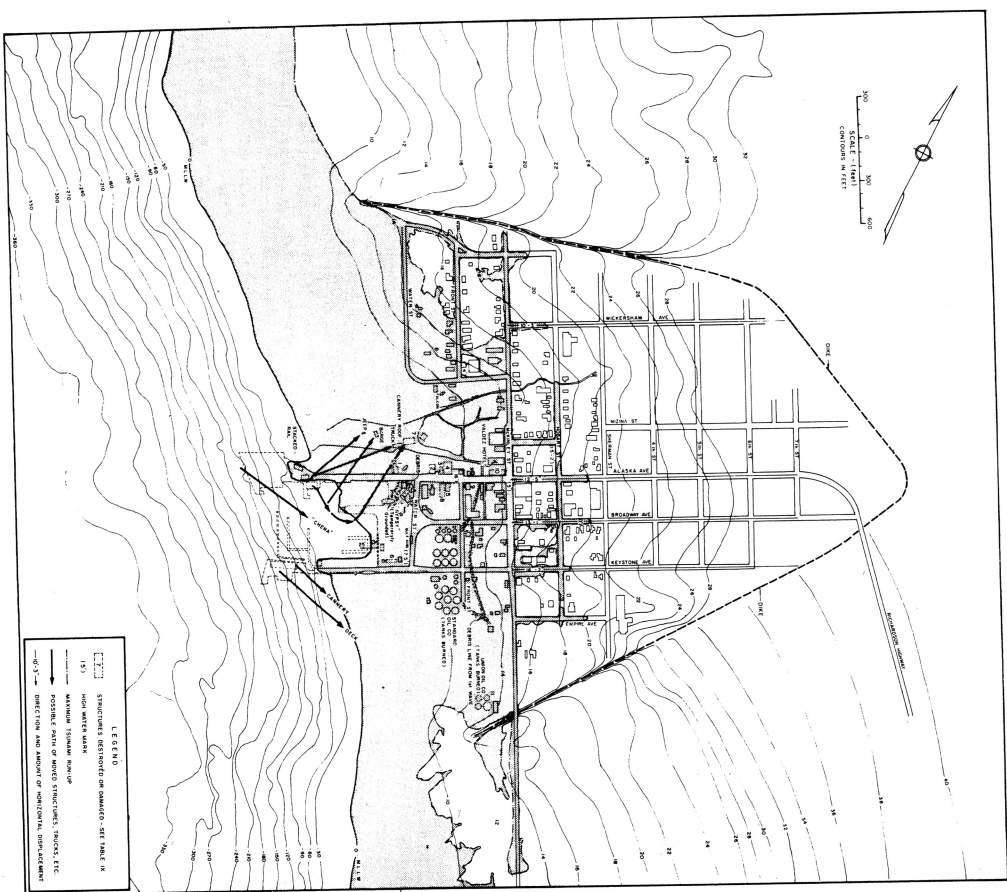
Figure 98 contains our interpretation of the runup levels attained by the highest waves. This is based on aerial photographs, careful examination of ground photographs, and

FIGURE 98 Plan of Valdez after the earthquake and tsunami, showing postearthquake contours and extent of inundation.

The initial waves caused damage to the whole waterfront and the downtown area as far as the ramp line shown in Figure 98. A wave, presumably the one that came in about 2½ minutes after the earthquake started, damaged almost all the boats and boat floats in the small-boat harbor. Many of the boats were beached temporarily and were washed into the bay by the higher waves later in the evening.

stroyed are given in Table 9; their location is identified by number in Figure 98.

Some heavy trucks from the docks were also washed inland (see Figures 98 and 103). The roof of the cannery from the inner end of the north dock was partly sunk in mud flats northeastward of the North Arm (Figures 98, 100, 102, and 103).
